Closure at the San Manuel Plant Site How Closure Aligned with the Goal of Environmental Sustainability¹

Dawn H. Garcia², P.G., and Terry Braun³, P.E.
SRK Consulting (U.S.), Inc.

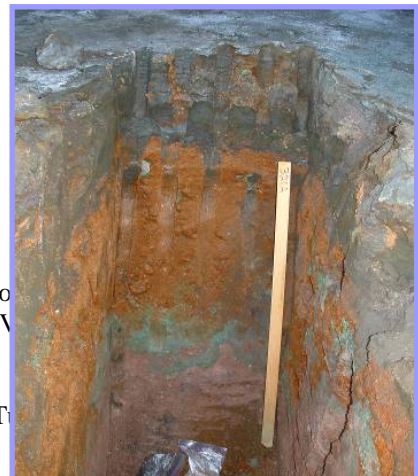
Photo 2: Soil characterization trench

contaminated soils within the Plant Area. Contaminated soils were generated within material staging areas as well as within areas of heavy industrial activity. In some cases, contaminated soils were located below fill materials (Photo 2). The primary soil contaminants are metals.

The selected remedial alternative is an engineering control, which will be a soil barrier, combined with access controls, will serve as the engineering control to manage human health risks that may be associated with the Plant Site soils that have metal concentrations above non-residential Soil Remediation Levels (SRLs) promulgated by the Arizona Administrative Code (A.A.C.) R-18-7-205. Use of an engineering control as a remedial option is consistent with the A.A.C. R18-7-206(D).

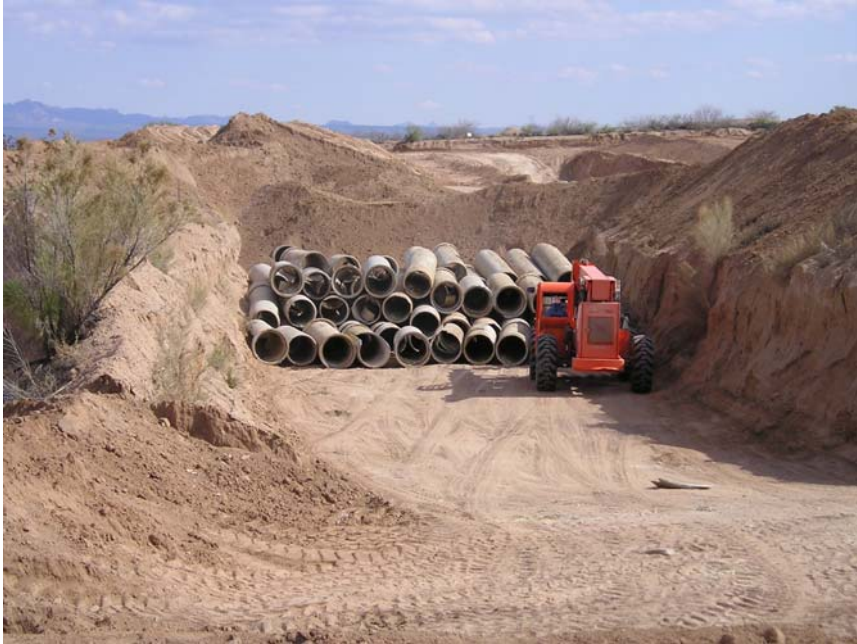
Photo 3: Transite pipe disposal in asbestos landfill

Each building was prepared for demolition following an environmental assessment. Asbestos siding, roofing, and insulation were removed prior to the building demolition where practical and safe. The asbestos was disposed of at the on-site permitted asbestos landfill. Equipment and areas where potential contaminants were handled were cleaned prior to salvage or demolition. Oils and grease were sent to a recycler or licensed waste disposal facility. Construction debris found to contain contaminants exceeding regulated levels was disposed of in an appropriate manner (such as incineration or disposal in a landfill).

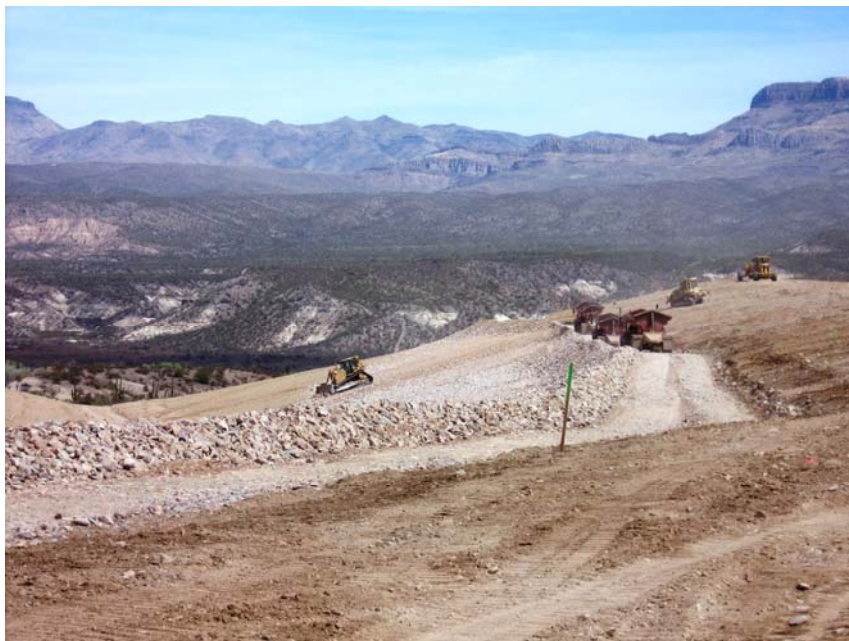
Photo 4: Installation of rock armor on 6 Dam

Stormwater runoff from the industrial area was captured on the tailings impoundments and then evaporated. Separate diversion berms and channels were constructed on the regraded and covered areas. The diversion berms and channels manage storm water and limit erosion through collection and diversion of storm water runoff from the covered area to natural drainages. Drainage patterns from the Plant Area towards the tailing impoundments will continue after closure of the Plant Area and Tailings Area; however, drainage from the Plant Area will be captured upgradient of the tailing impoundments in the clean water diversion channels and discharged off site (Photo 4).
